Case Study

Rosedale Products filter out Carbon Deposits to Protect Machine for Precision Engineering Company

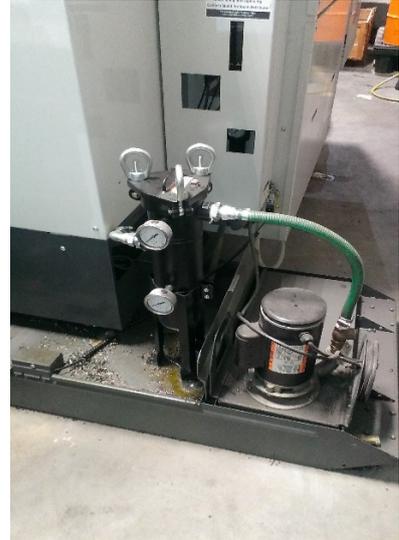
Rosedale Products Europe Ltd is based in Wakefield and offered a two pronged approach to solving the problem. After the initial meeting and subsequent testing of the coolant to determine the particle sizes, a quotation was submitted. Rosedale Products were awarded the order to proceed and the first thing was to arrange a convenient time and date with the customer for the Rosedale Service Engineer install an inline filter from the machine main pump to the spindle feed so all coolant flowing to the machine head was filtered prior to being used on the component. This was reached by fitting a Rosedale model 4-12 carbon steel filter housing with a 10 micron Polypropylene filter bag inside the housing, piped direct into the main feed line fitted with differential pressure gauges to enable the operator to easily identify when the filter was blocking.

The second application was to fit an off line larger model 8-30 filter housing fitted with a 25 Micron Polypropylene filter bag fed directly from the main machine sump via a centrifugal pump acting like a dialysis type filter. Once again this was fitted with differential gauges to enable operators to identify when the filter was becoming blocked and in need of replacement.
